TECHNICAL INFORMATION REPORT

Brown Bear - New Build

55 N.W. Gilman Boulevard
Issaquah, Washington

April 3, 2020
Our Job No. 20693

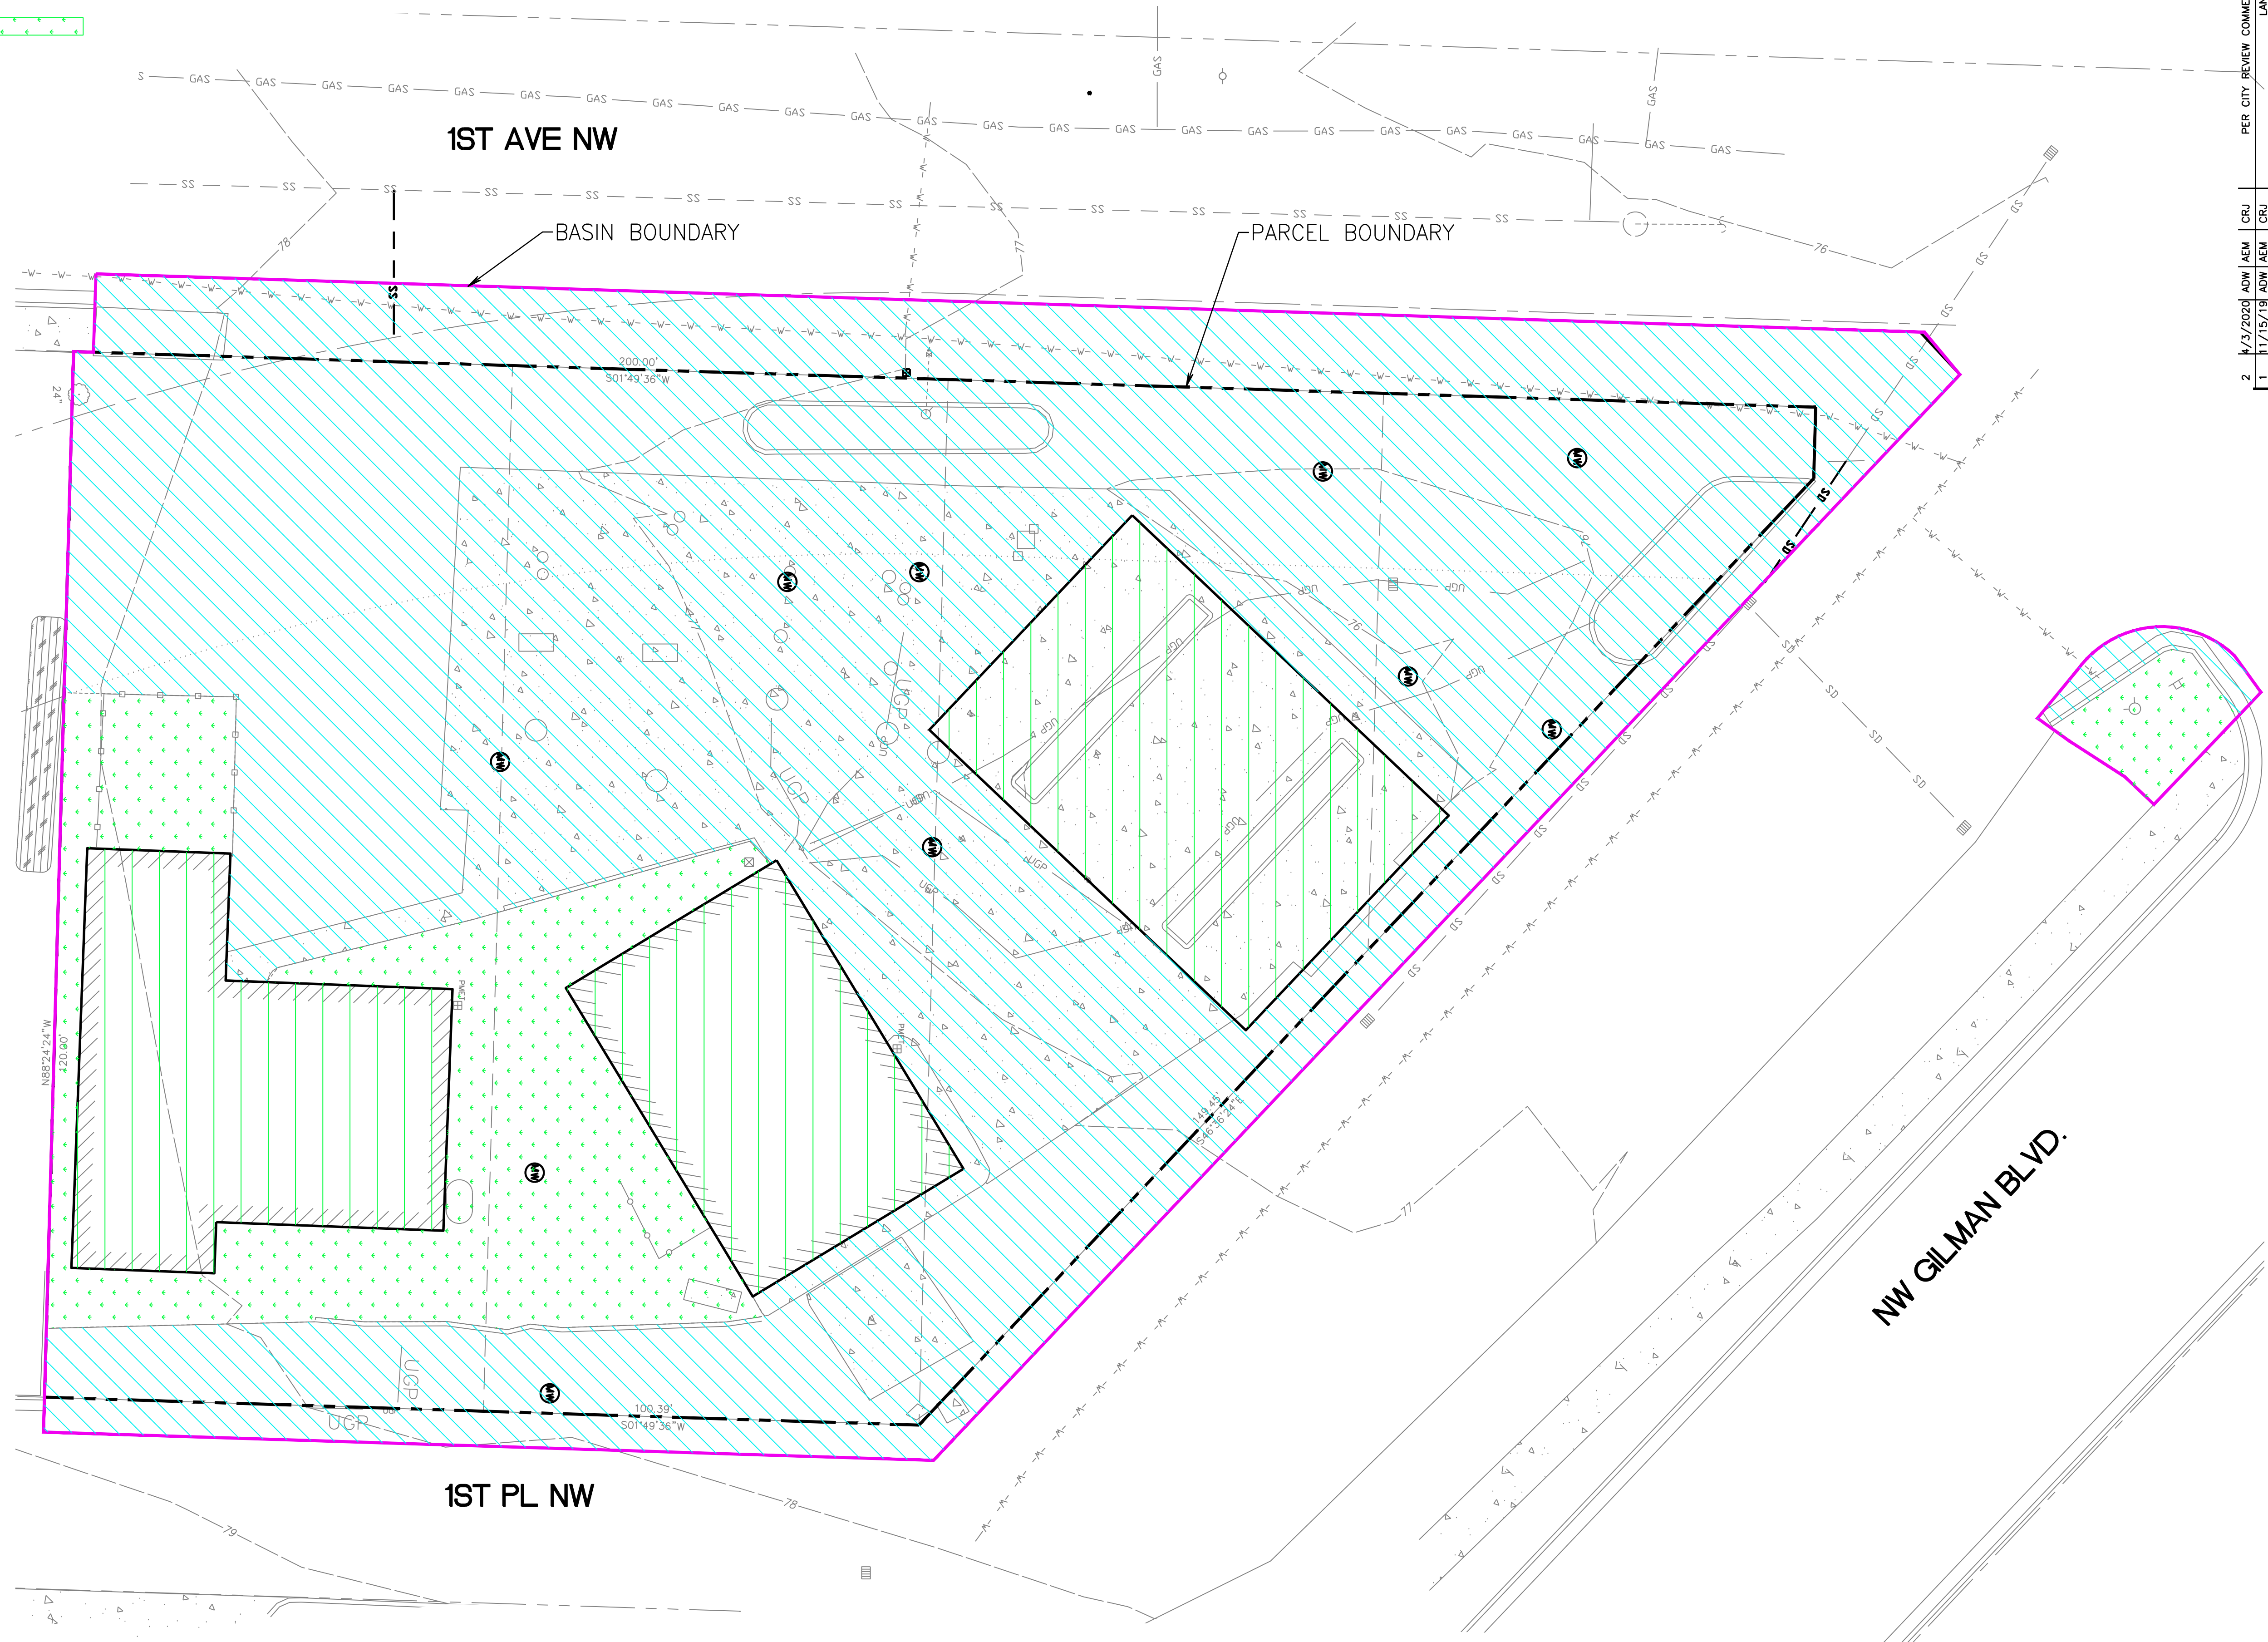
Figure 5.1 Pre-developed Basin Map

The predeveloped basin, tributary to the site discharge location, can be broken down as follows:

PRE-DEVELOPED BASIN AREAS:

EXISTING IMPERVIOUS/PERVIOUS AREAS

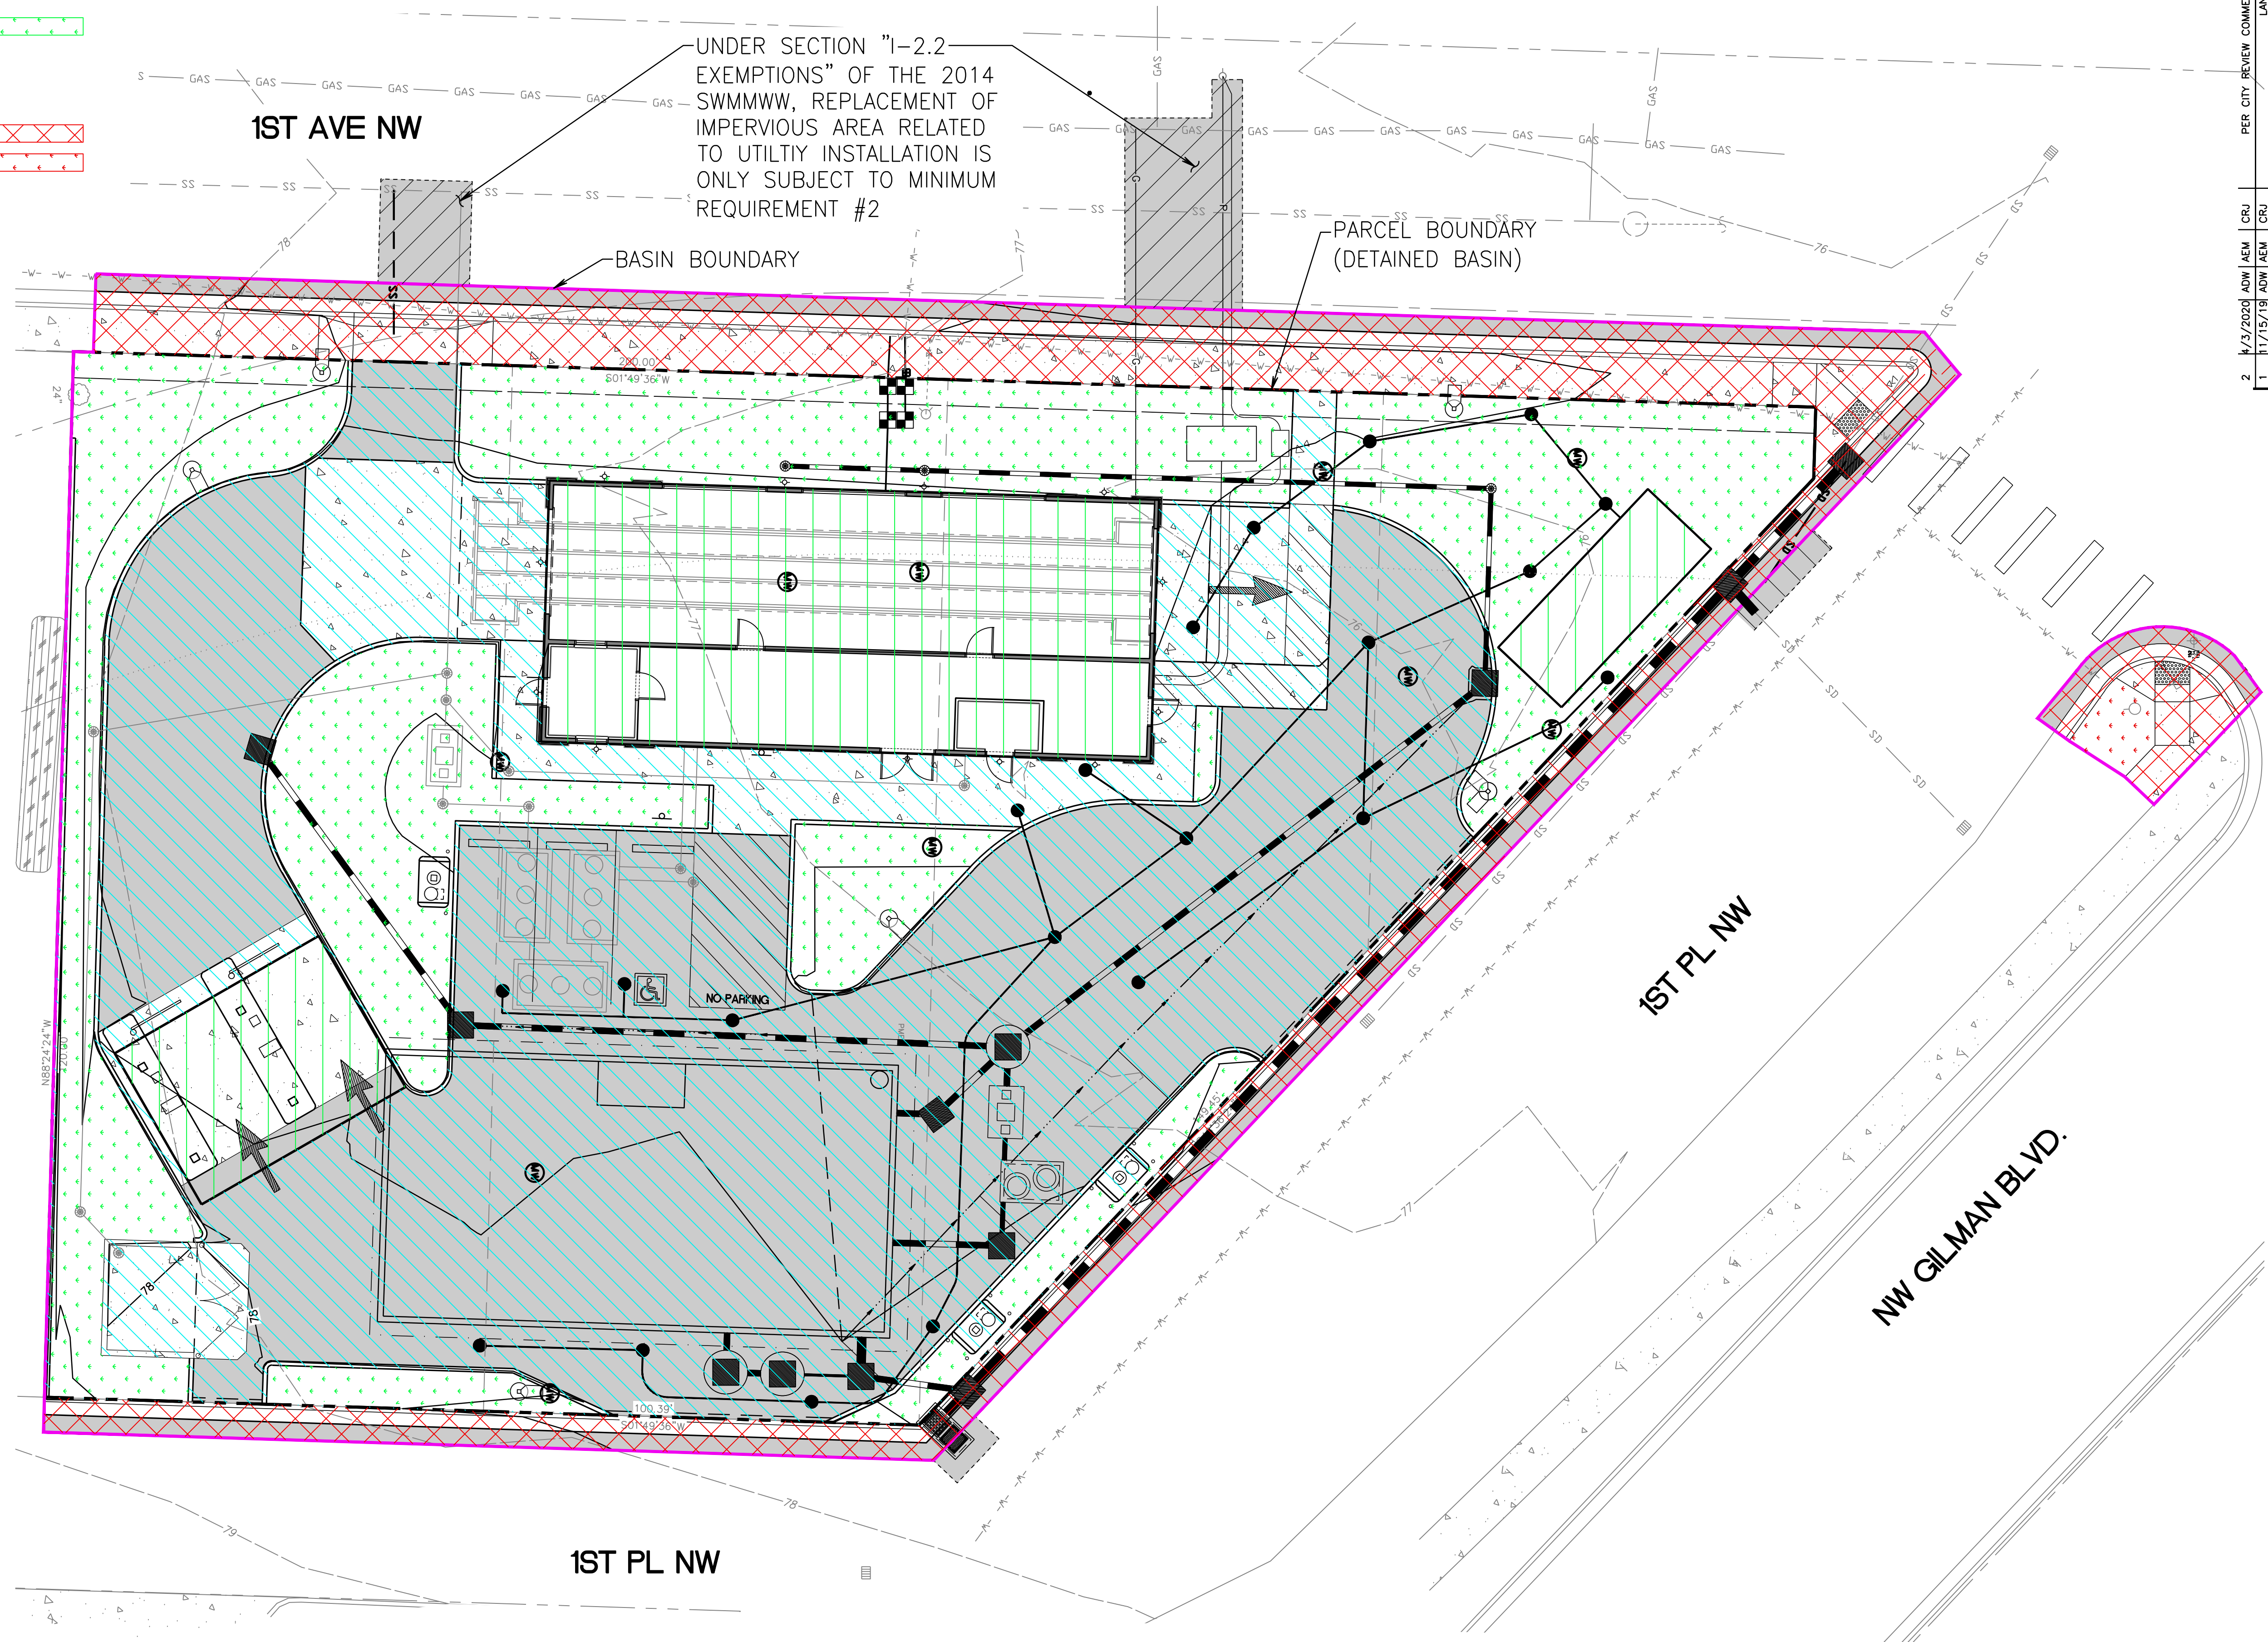
Figure 5.2

The developed basin, tributary to the site discharge location, can be broken down as follows:

DETAINED BASIN AREA:

NEW AND REPLACED IMPERVIOUS/PERVIOUS AREAS

TOTAL NEW AND REPLACED IMPERVIOUS:	13,184 SF (0.303 AC)	
LANDSCAPE:	5,247 SF (0.120 AC)

NEW AND REPLACED IMPERVIOUS AREAS (BYPASS)

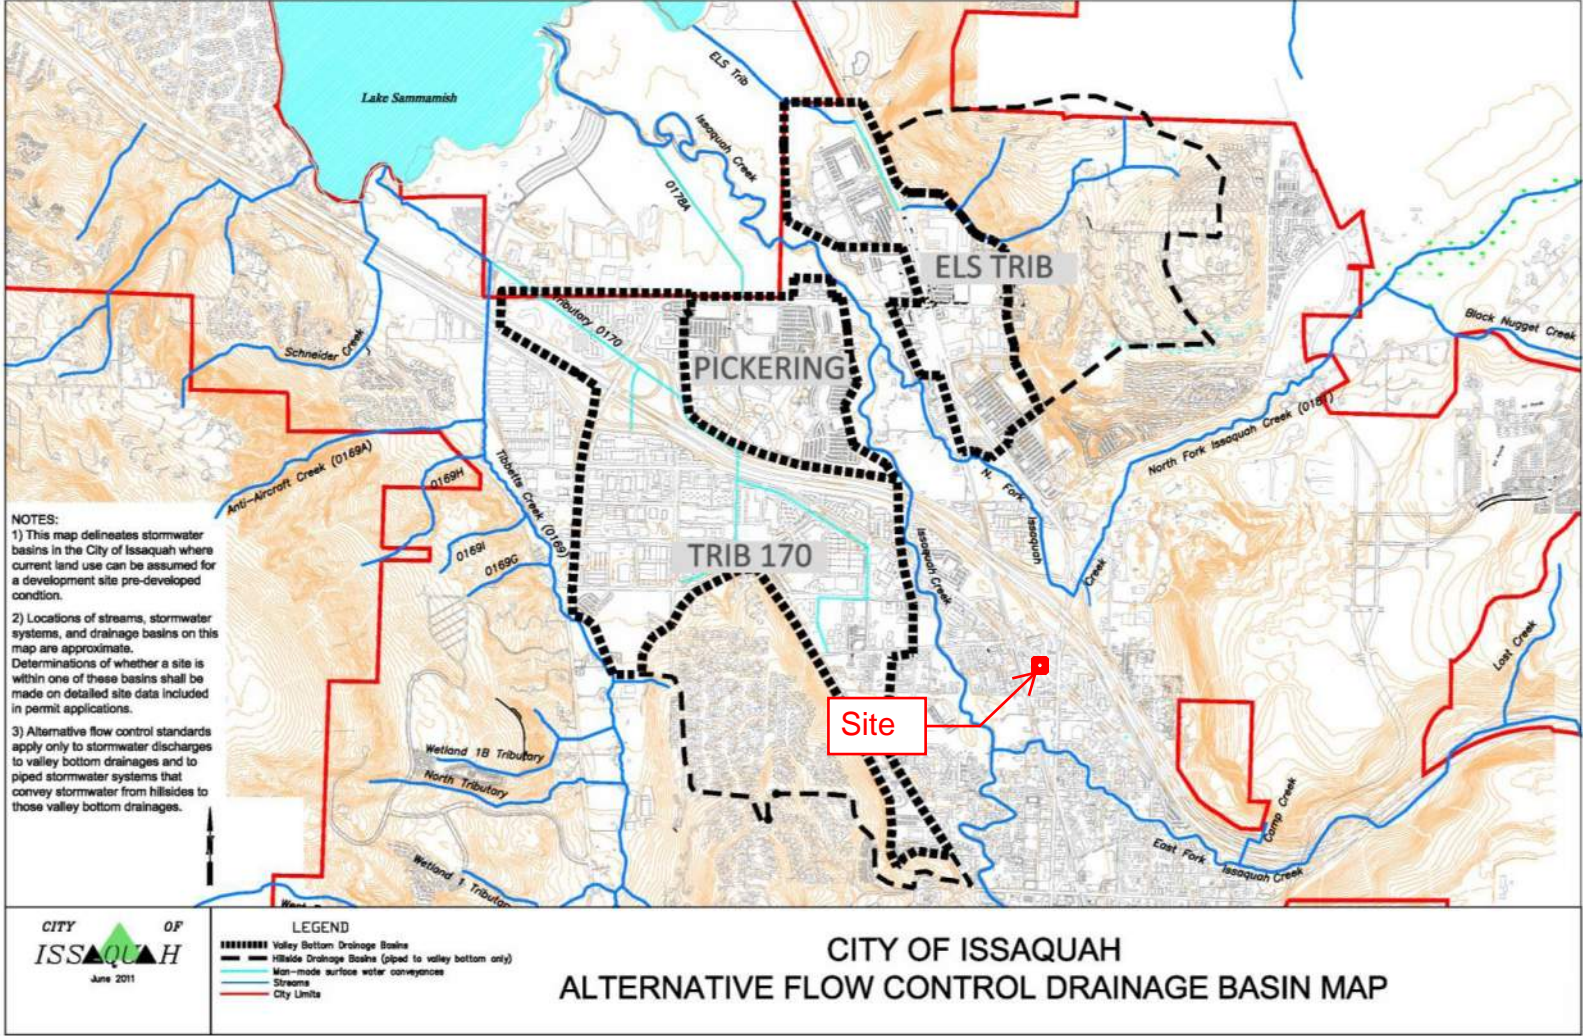
Figure 5.6
Central Issaquah Area
Alternative Flow
Control Standard Map

Figure 2-5. Central Issaquah Area Alternative Flow Control Standard Map

This project proposes to create more than 10,000 square feet of new and replaced impervious surface within a threshold discharge area, and is located outside the City of Issaquah Alternative Flow Control Drainage Basin. This project site's existing surface contains greater than 35 percent impervious surface coverage and is therefore defined as a redevelopment project. The anticipated increase value of the site improvements will likely be greater than 50 percent of the value of existing site improvements; therefore, all new and replaced hard surfaces are considered targeted surfaces. Additionally, the pre-developed condition of the site must be modeled as forested for the purpose of flow control calculations. This project will provide flow control to "Match developed discharge durations to pre-developed duration for the range of predeveloped discharge rates from 50 percent of the 2-year peak flow up to the full 50-year peak flow" per Minimum Requirement No. 7.

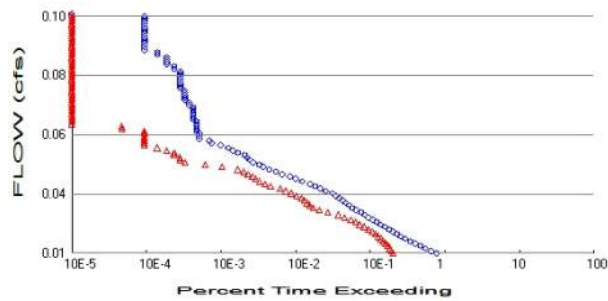
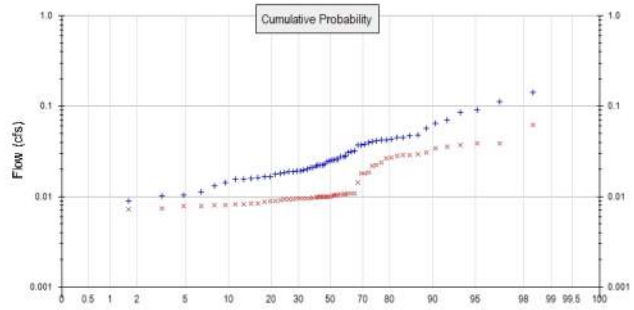
POC 1

+ Predeveloped x Mitigated

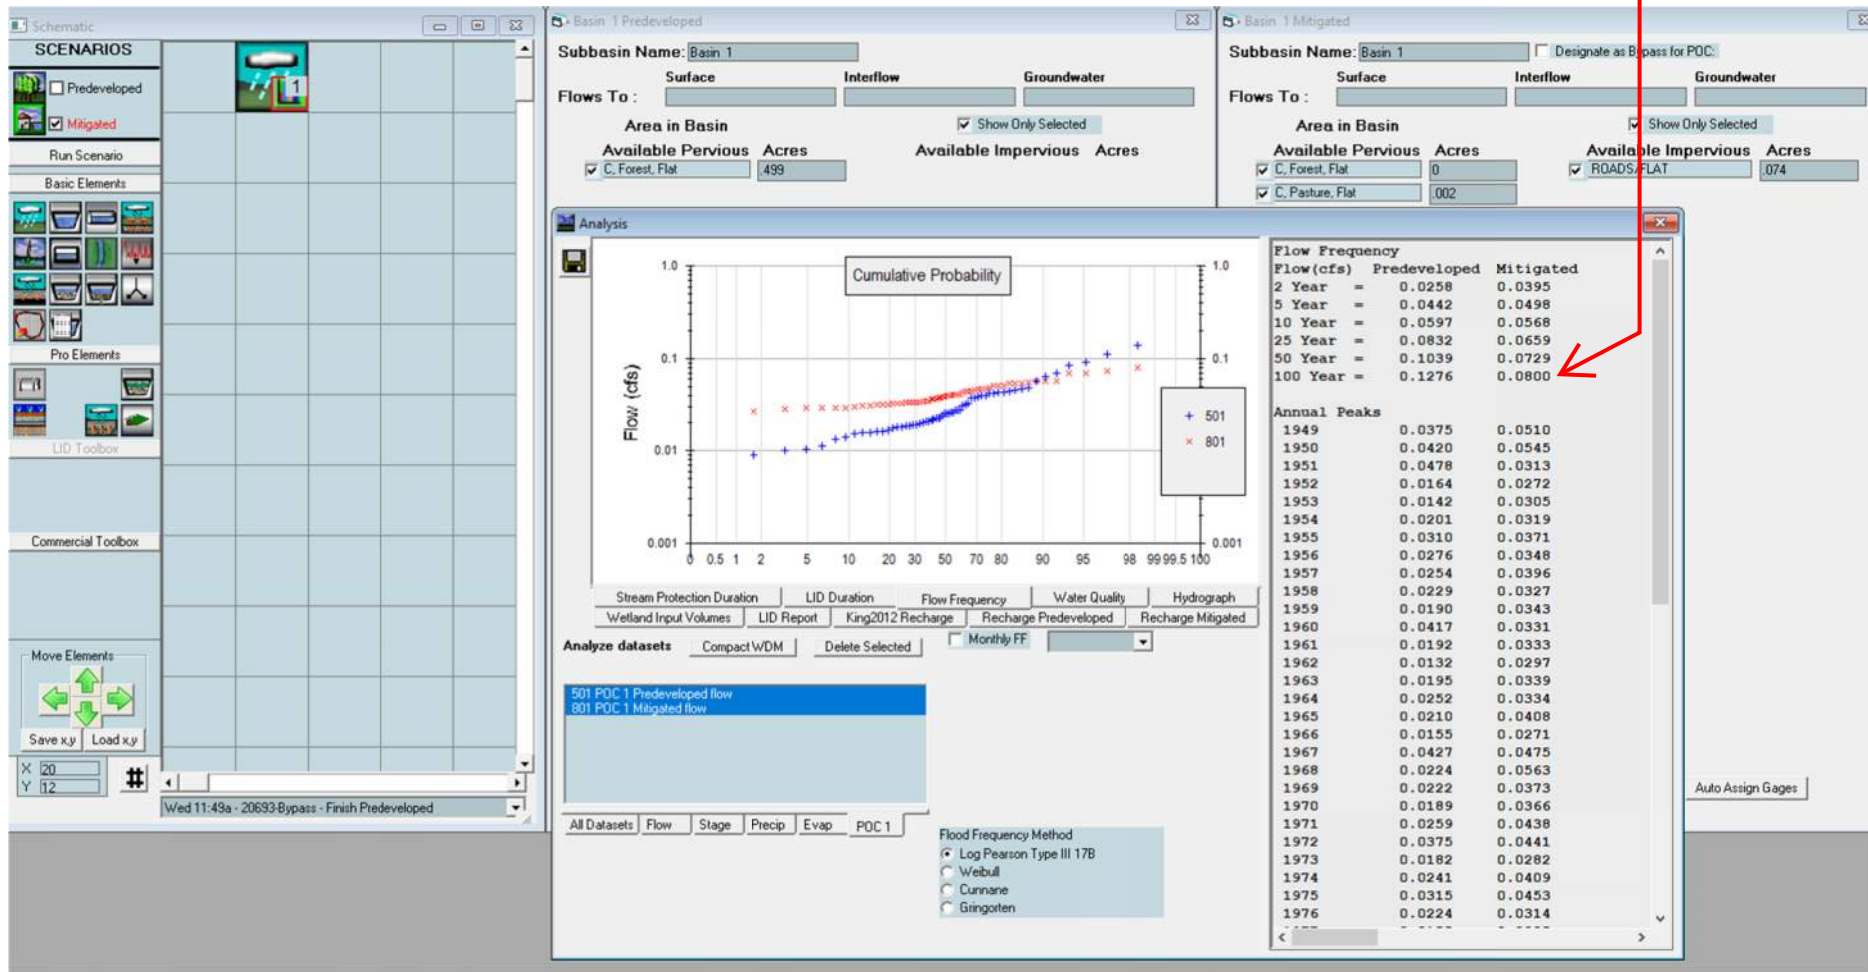
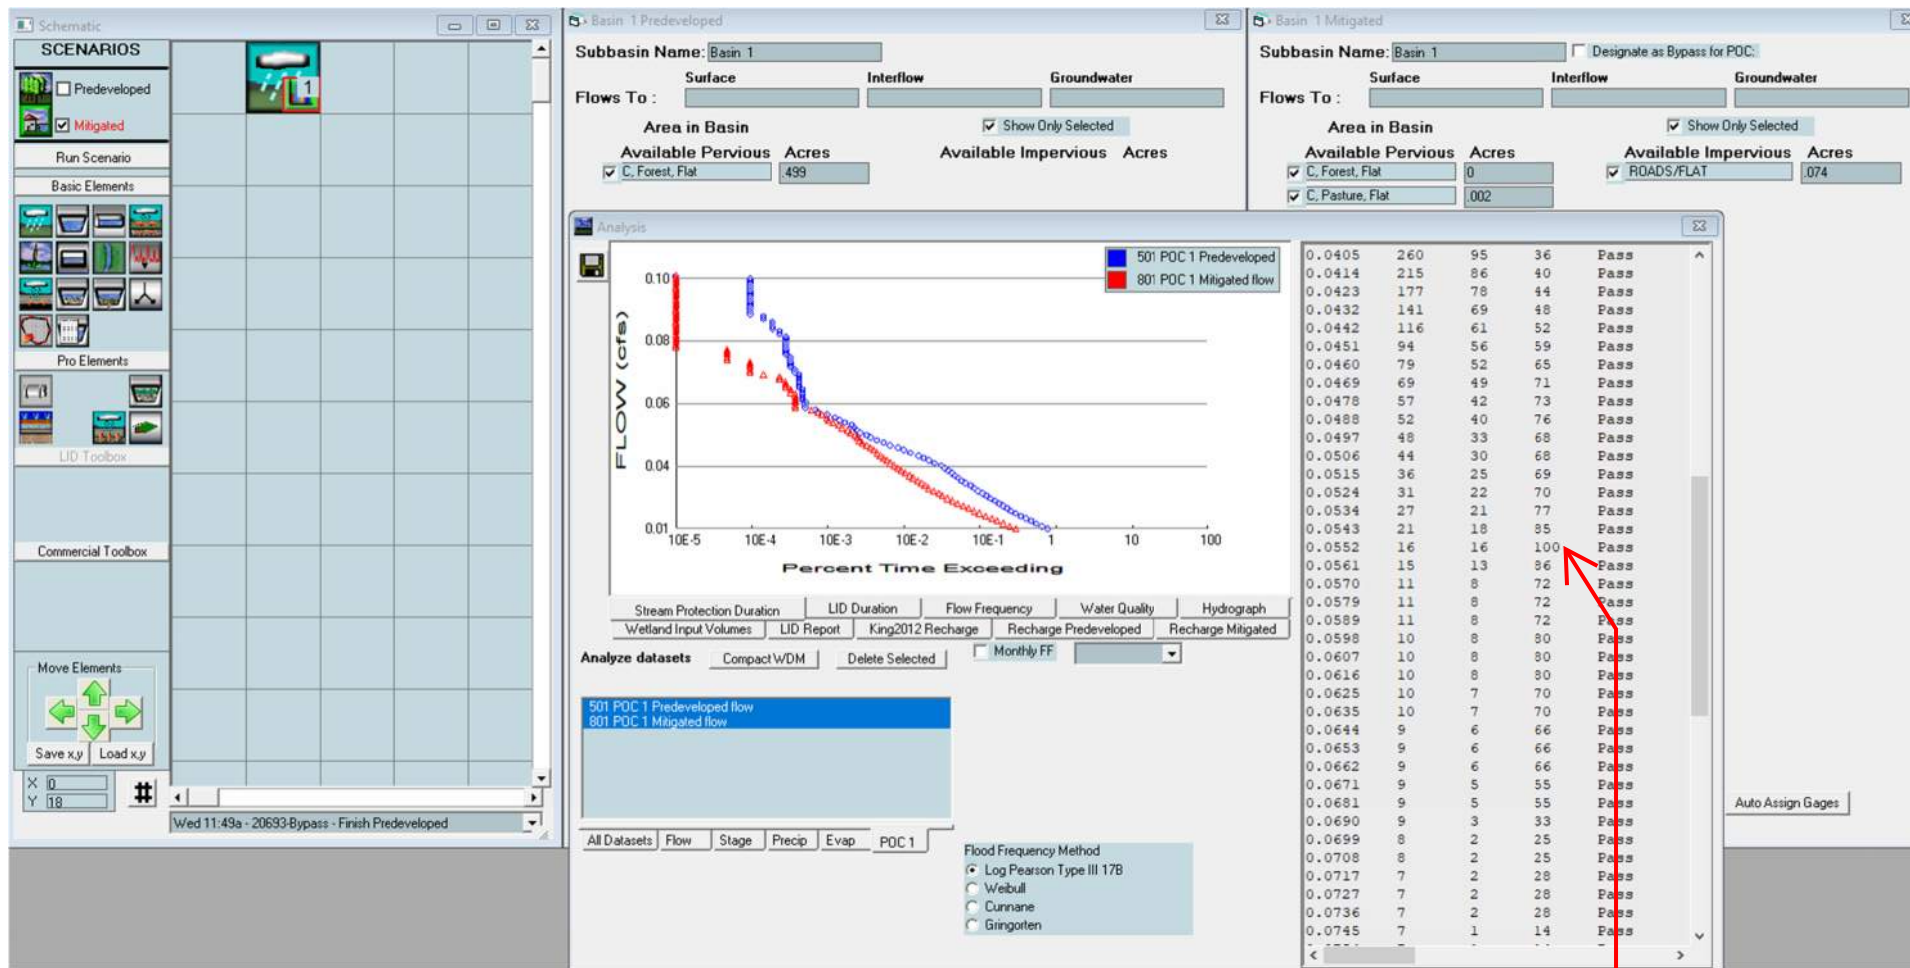
Figure 5.8 Bypass Runoff Calculations

Bypass Areas alone matches entire pre-developed site. Cannot model as "bypass" in detention calcs.

Improvements within the public right-of-way will bypass the detention system, as they cannot be feasibly isolated from the surrounding street surfaces, and collected. WWHM2012 calculation indicate that flow rate durations of the bypass area alone closely match the pre-developed flow rate durations for the entire site.; therefore, it will not be possible or feasible to design a detention system that will meet the flow control standard if the bypass area is modeled as un-detained runoff. Per the 2014 DOE SWMMWW, Volume III – Appendix B, the following conditions for the bypass area must be met:

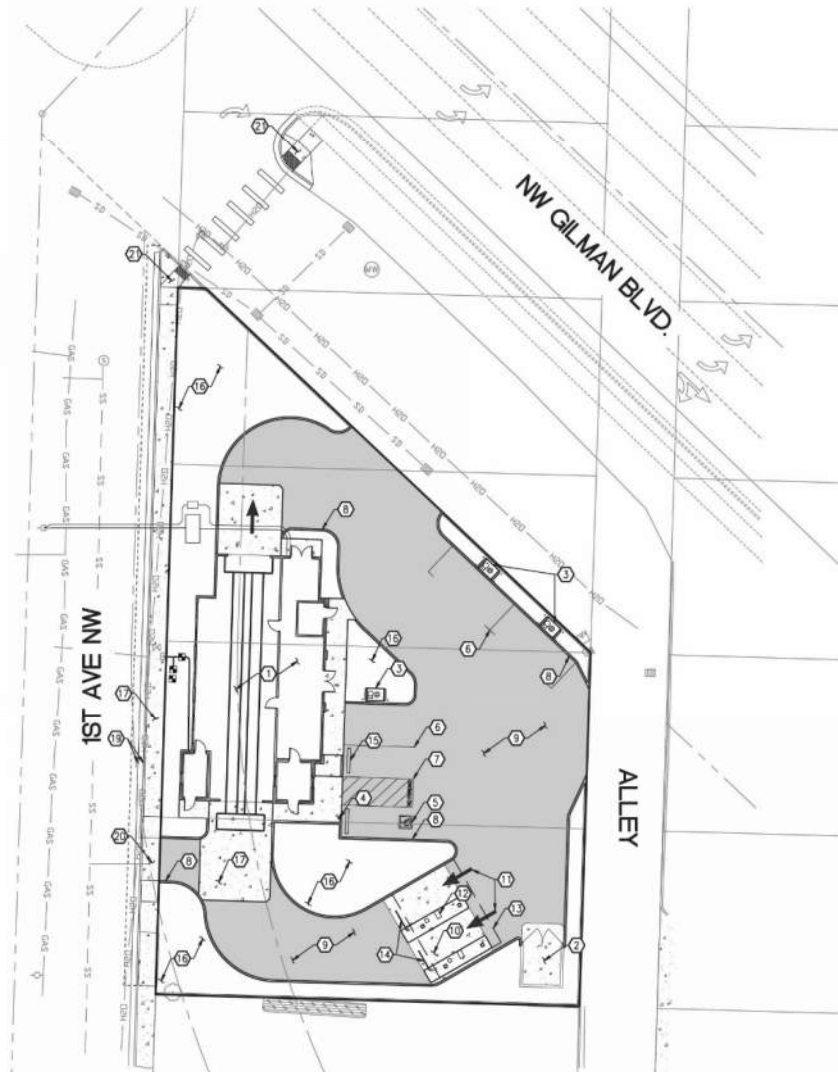
FS

1. NEW BROWN BEAR CAR WASH.
2. NEW TRASH ENCLOSURE WITH CONCRETE PAD.
3. NEW VACUUM UNIT.
4. NEW ACCESSIBLE PARKING SIGN.
5. NEW ACCESSIBLE PAVEMENT SYMBOL.
6. PARKING STALL MARKINGS SHALL BE 4" WIDE WHITE PAINTED STRIPES TO DIMENSIONS (TYP.).
7. PAVEMENT MARKINGS - 4" WIDE WHITE PAINTED STRIPES @ 3' O.C. / 45° ANGLE.
8. NEW ON-SITE BARRIER CURB.
9. NEW ASPHALT PAVEMENT.
10. NEW CONCRETE SLAB UNDER CANOPY.
11. WHITE PAINTED DIRECTION ARROWS.
12. NEW AUTO SENTRY.
13. NEW AUTO SENTRY CANOPY.
14. NEW CLEARANCE SIGN.
15. NEW WHEEL STOP (TYP. OF 2).
16. NEW LANDSCAPING.
17. NEW CONCRETE SLAB.
18. NEW OFF-SITE SIDEWALK PER CITY OF ISSAQUAH STANDARD DRAWING T-38.
19. NEW CURB AND GUTTER PER CITY OF ISSAQUAH STANDARD DRAWING T-38.
20. NEW COMMERCIAL DRIVEWAY FOR CARWASH BYPASS PER CITY OF ISSAQUAH STANDARD DRAWING T-38.
21. NEW PERPENDICULAR RAMP PER CITY OF ISSAQUAH STANDARD DRAWING T-08.

The proposed Brown Bear Car Wash facility would include the construction of a single 2,524 SF car wash tunnel. A preliminary site plan is included as **Attachment A**.
